H-IIA Rocket Engine Development

The first-stage LE-7A and second-stage LE-5B engines of the H-IIA launch vehicle started being developed in 1994, with the LE-5B development completed in 2000, the LE-7A development is still under way to improve the engine further. Failures occurred in the H-II Flight No.5 launch in 1998 where the second-stage engine, the LE-5A, failed and in the H-II Flight No.8 launch in 1999 where the first-stage engine, the LE-7, failed. Development of these engines was continued improving the development plan reflecting the cause of these launch failures. Both engines operated satisfactory in 2001 during the maiden flight of the H-IIA.

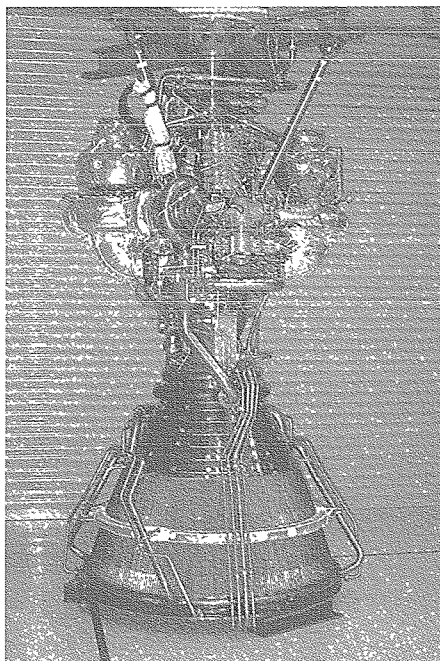
Fig. 1 LE-7A engine

Fig. 1 shows a picture of the LE-7A engine. This engine has been developed by improving the LE-7 engine which was used as the first stage engine on the H-II launch vehicle. The LE-7A engine operates on the same combustion cycle (staged combustion cycle) as that of the LE-7 but has higher reliability, lower cost and higher performance⁽¹⁾⁽²⁾. In order to add the throttling capability for the purpose of enhancing engine performance, the lower nozzle extension is designed as sheet metal construction with film cooling. However, this modification brought about an unexpected problem in the later stage.

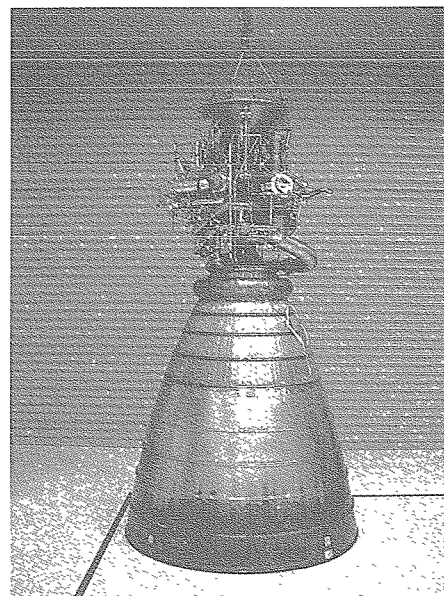
Fig. 2 LE-5B engine

Fig. 2 shows a picture of the LE-5B engine. The LE-5B engine has been developed by increasing the

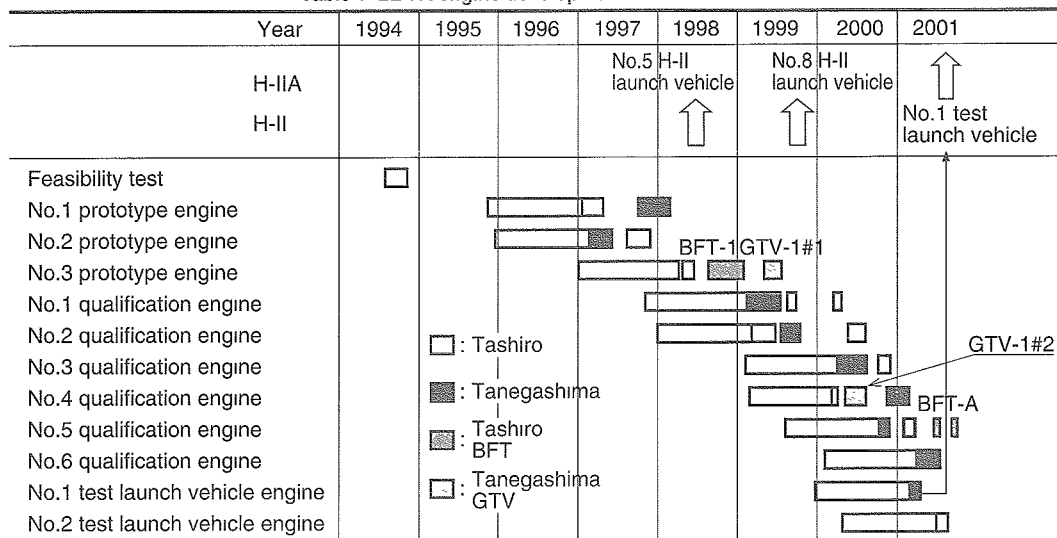
Table 1 LE-7A engine development schedule

After the above-mentioned preventive measures had been implemented, manufacture of the qualification engine designed for actual flight operation was started in 1998, reflecting the test results of the prototype engines. In 1999, qualification tests were started on the two units of the qualification engine. No.1 and No.2 qualification engines underwent combustion tests for 17 times/1501 seconds and 12 times/1618 seconds, respectively, until September 1999, but the following failures were found during these tests:

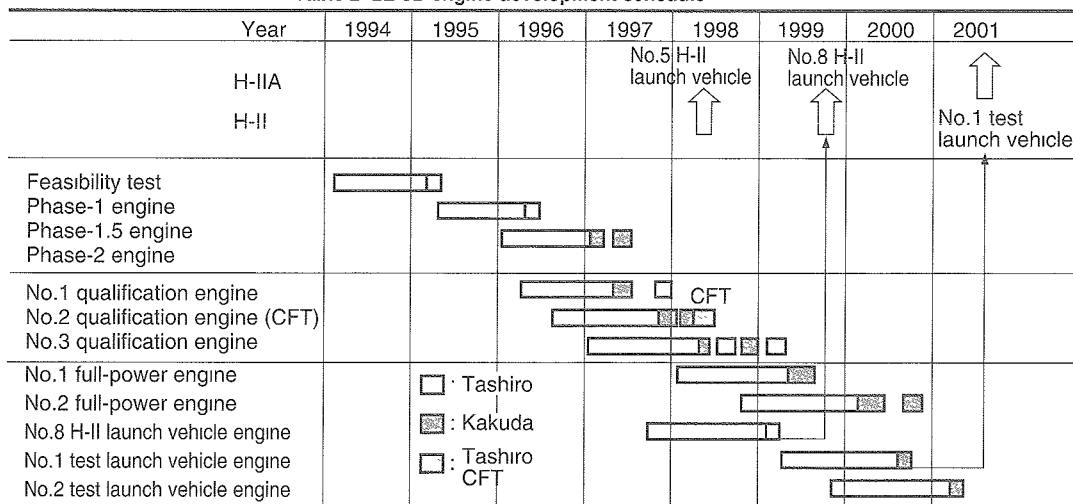
Table 2 LE-5B engine development schedule

Table 2 shows the LE-5B engine development schedule. The development of the LE-5B engine was started in 1994. In 1955, an LE-5A engine, which was used for the development test, was modified with its combustion chamber replaced with a copper cooling-channel-milled combustion chamber, and its injector also modified to adjust the injection velocity ratio. The engine thus modified underwent the feasibility

hot firing test for 8 times/237 seconds for verification of the effectiveness of the expander bleed cycle and the structural integrity of the combustion chamber.

In 1996, the phase-1 engine equipped with the injector designed for the LE-5B engine and the combustion chamber used in the feasibility test underwent the hot firing test for 13 times/931 seconds, including throttling combustion and idle mode operation. The test results of the phase-1 engine were generally acceptable, except that combustion efficiency was low at about 96 percent. The reason of low combustion efficiency was thought that the hydrogen injection temperature of the main injector was lower than the originally designed temperature. Two possible methods of increasing the hydrogen injection temperature were considered: one was to install a swirler on the main injector LOX post to accelerate the propellant mixing, and the other was to extend the combustion chamber to promote heat absorption.
